SOUTH EAST QUEENSLAND
HEALTHY WATERWAYS
PARTNERSHIP

**A Review of Water Quality and
Maintenance Costs of Constructed
Water Bodies in Urban Areas of
South East Queensland**

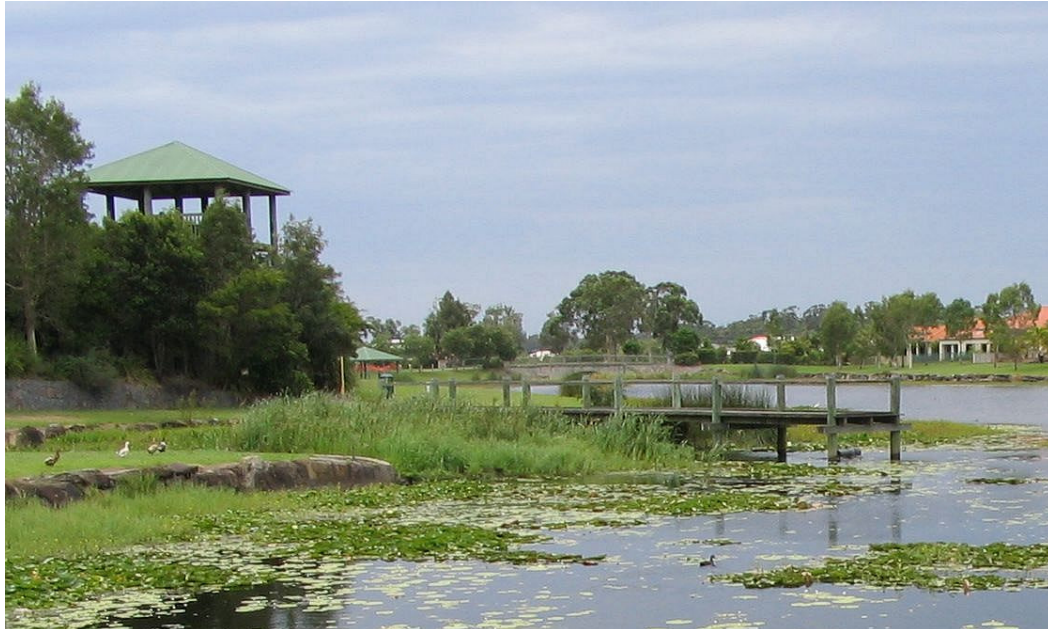
Figure 2-1 Submerged and Emergent Macrophytes in an Urban Lake

The occurrence of aquatic macrophytes within urban lakes (both submerged and emergent) are sometimes considered undesirable in maintaining aesthetics and recreational function. However, macrophytes play a vital role in proper ecosystem function. Submerged macrophytes are considered the most effective in managing nutrient uptake, reducing turbidity, and providing suitable habitat for certain aquatic fauna. However, the presence of macrophytes does not reduce the need to effectively manage catchment loads.

Aquatic systems dominated by submerged macrophytes can be resilient to low levels of nutrient inputs from catchments. However, higher catchment loads can compromise the assimilative capacity of systems such that catastrophic failure of the entire lake ecosystem may occur and a switch over to one that is dominated by phytoplankton blooms (Bailey et al. 2002).

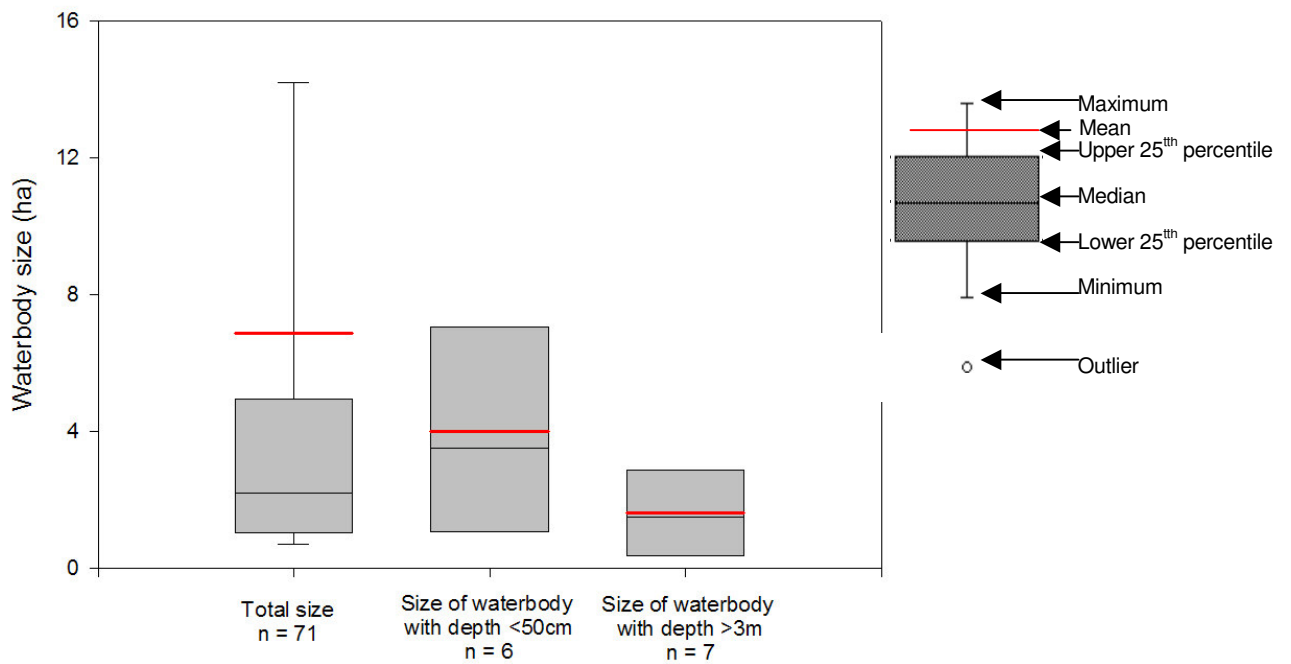
Figure 3-2 Water Body Surface Area

The surface area of the majority of urban water bodies within SEQ is less than 10 ha, with the mean of all data collected being 6.7 ha as shown in Table 3-1. However, this does not imply that they are all typically that size, as there was a significant variance in range with a minimum of 0.5 ha up to a maximum of 95 ha. From the raw data, it is apparent that the larger water bodies within urban areas in SEQ tend to be centred around the Gold Coast. Eighty percent of water bodies identified in the survey were less than 6 ha in size, as indicated by the box and whisker plots in Figure 3-2.

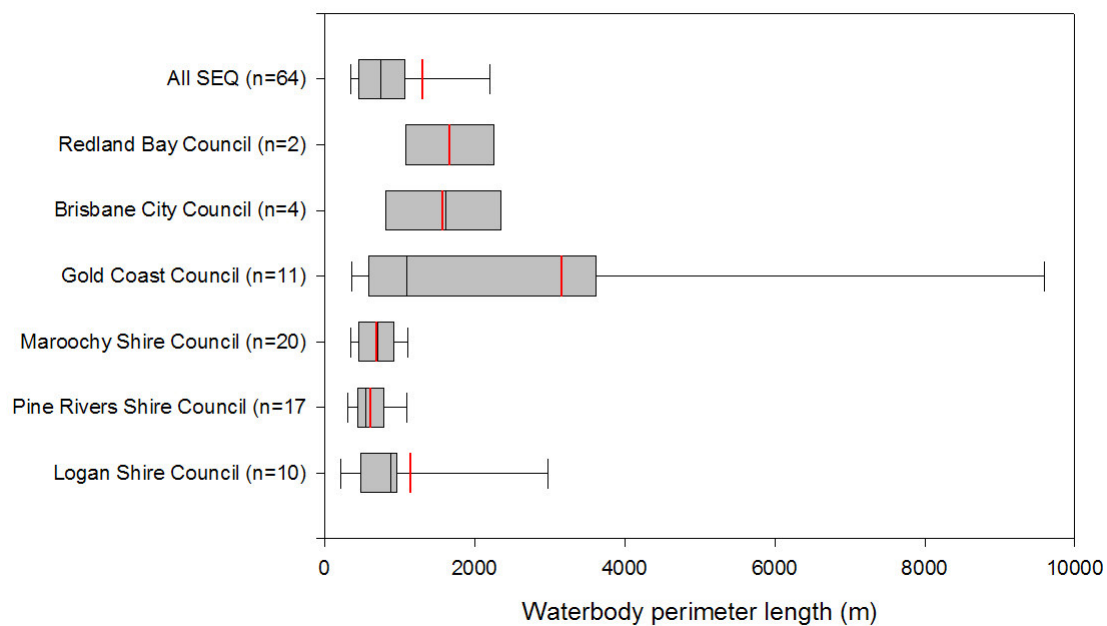
Figure 4: Perimeter length of waterbodies within SEQ LGA's. Note n values.

Most participating councils provided relatively good information of the perimeter of waterbodies within their jurisdiction. Perimeter data was reported for 64 of the 83 water bodies. The range in water body perimeter length was large (290m – 20,000m) within the data set, with the Gold Coast Council waterbody “Clear Waters Island” being 13,000m longer than any other waterbody within SEQ. This lead to the calculated mean waterbody perimeter within SEQ being greater than the majority of the data set. Approximately 75% of the waterbodies within the participating SEQ local government areas have a perimeter length of between 500 and 1000m. Four out of the eleven waterbodies within Gold Coast City exceed a perimeter length of 3000m.

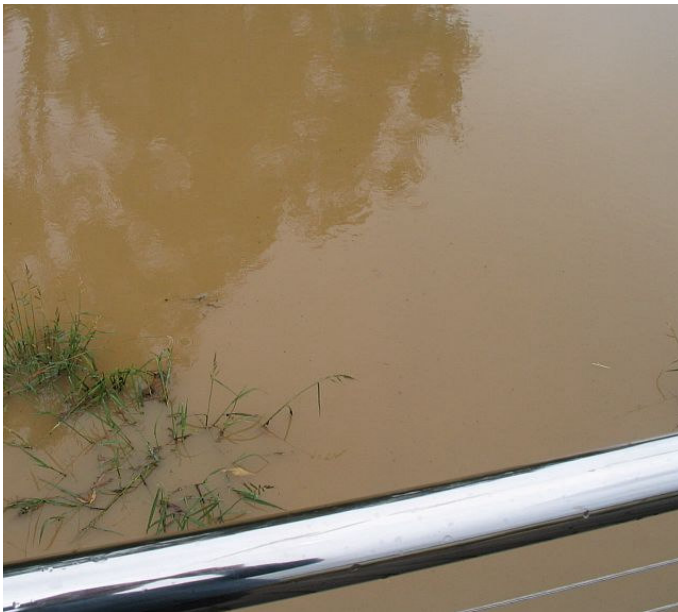
Figure 3-3 Turbid Water During Construction Phase

Turbidity indicates the clarity of the water column, a key feature of the aesthetics of a water body. Turbidity within water bodies can be very high during the construction phase of urban development (see Figure 3-3), but will typically decline during establishment of a functional aquatic ecosystem.

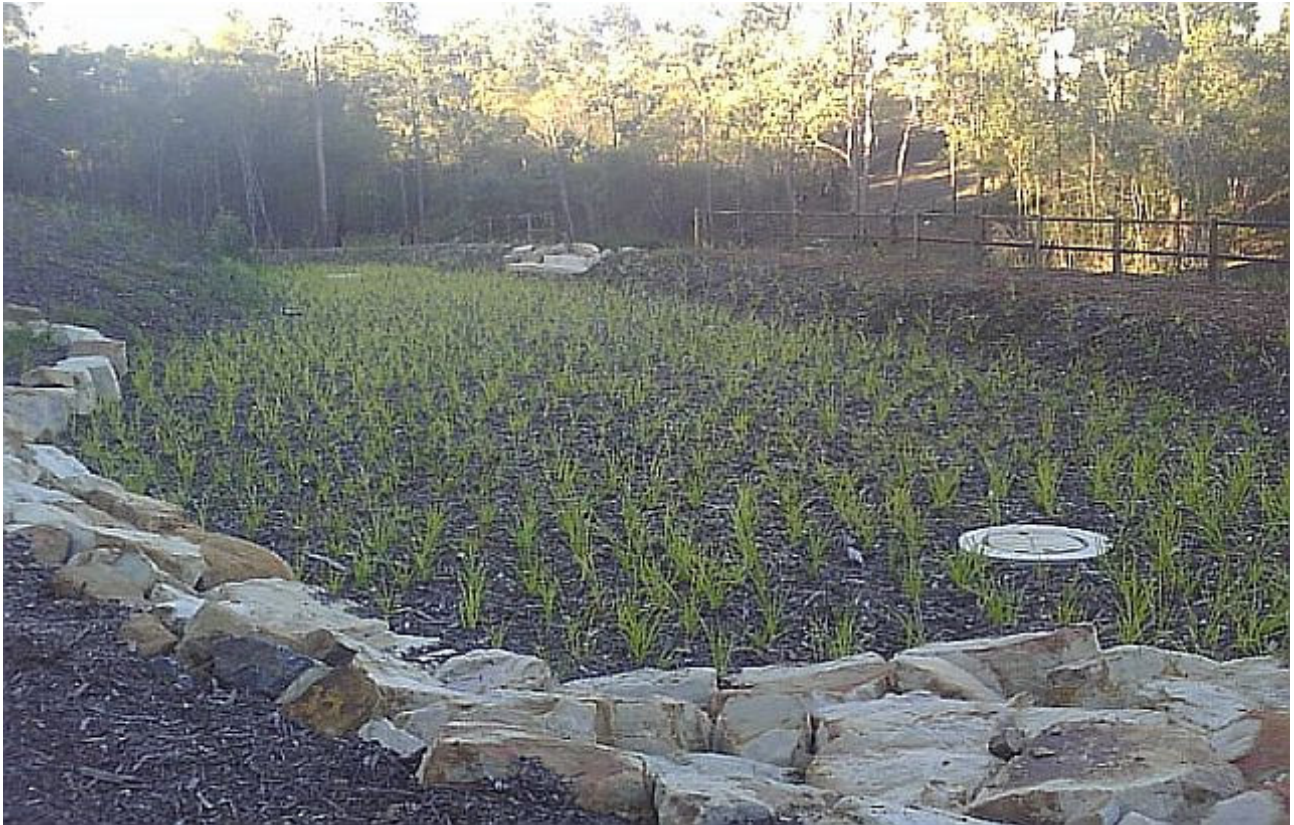
Figure 3-4 Water body Bioretention Pretreatment System

From the submitted data, some form of stormwater quality treatment was provided for 23 of the 83 identified systems. Water quality treatment measures were identified as either pre-treatment of inflows (using, for example, constructed wetlands, gross pollutant traps or bioretention systems), or in-situ treatment (such as mechanical destratification, aeration or recirculation). In-situ treatment of water bodies was usually through mechanical aeration and/or destratification devices which aimed to improve mixing of the water column.

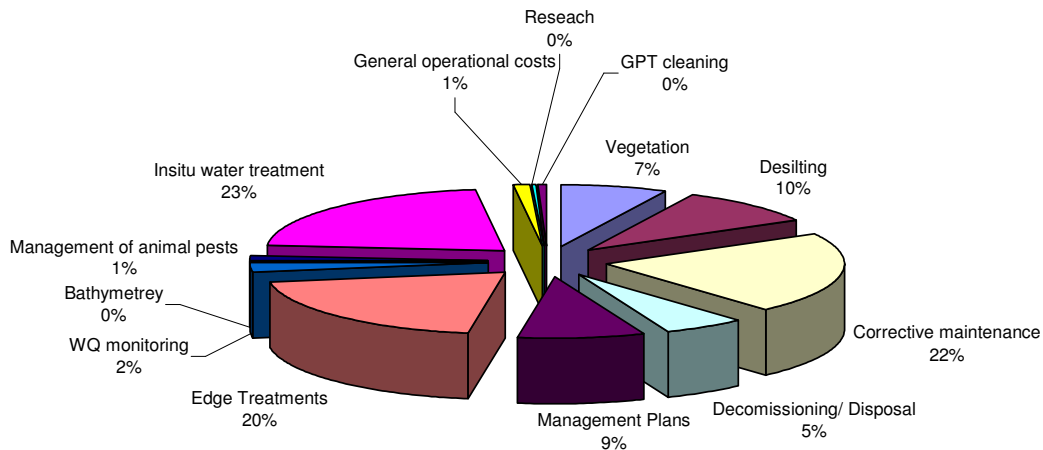
Figure 4-1 Distribution of costs to maintenance activities

Maintenance activities can be divided into **routine** maintenance and **corrective** maintenance. Routine maintenance consists of regular tasks or expenses necessary to operate and maintain an acceptable level of functionality of the system. For example, vegetation harvesting, cleaning of pre-treatment devices or running costs for an artificial recirculation system. These are costs that can be anticipated on a regular cycle. Corrective maintenance includes works required to restore deteriorated or malfunctioning components of the system. For example, repair of revetment walls or installation of an in-situ treatment system. These costs are more difficult to estimate and can often involve substantial expenditure. Major corrective maintenance activities were undertaken by all councils submitting cost data. Based on the analysis of the maintenance data, the **management of vegetation** within waterbodies and **corrective maintenance procedures** were the two most significant maintenance activities undertaken by councils.

The distribution of costs to these activities is shown in Figure 4-1 and Table 4-2.

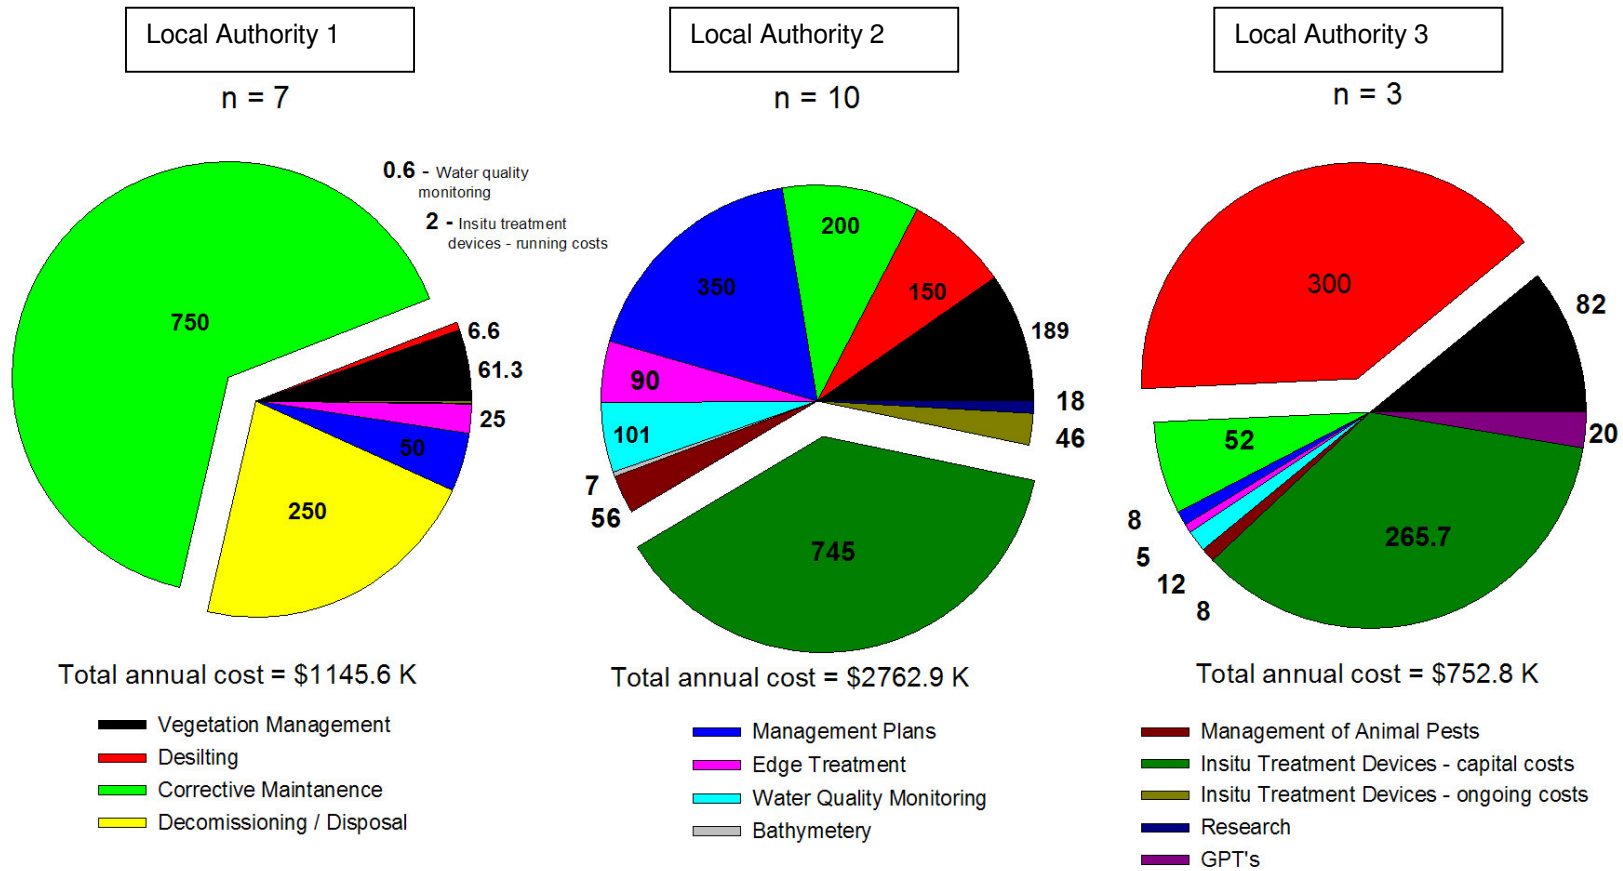
Figure 4-2 Individual LGA Maintenance Costs

The total sum of routine and corrective maintenance costs for the 2005/06 financial year for the 20 identified waterbodies was \$4,755,000. As shown in Table 4-2, routine maintenance of the relevant urban waterbodies in 2005/06 totalled just over \$3 million dollars. Corrective maintenance procedures over the same period totalled about \$1.7 million. The distribution of costs to different maintenance activities for the three local governments submitting cost data is shown in Figure 4-2.
