**Constructed Waterbodies in Urban Areas of South East  
Queensland:  
Maintenance Issues and Costs to Local Government**

**Version 1.0, 27 August 2007**

A Discussion Paper prepared by the South East Queensland Healthy Waterways Partnership on behalf of Local Government Partners.

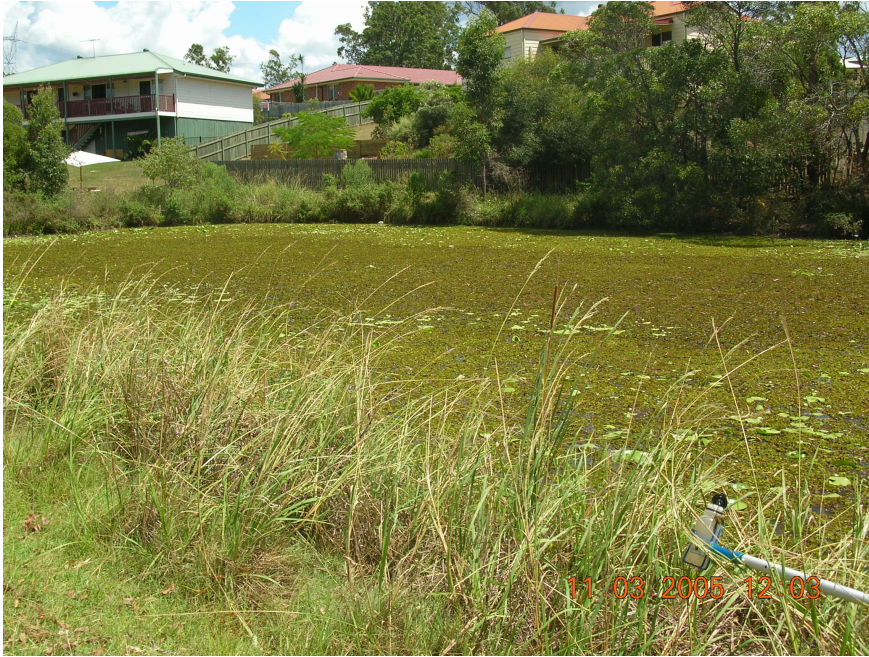
**Figure 1 Excessive macrophyte growth in an urban waterbody**

Figures 1 and 2 illustrate the potential effects of these processes on urban waterbodies in SEQ.

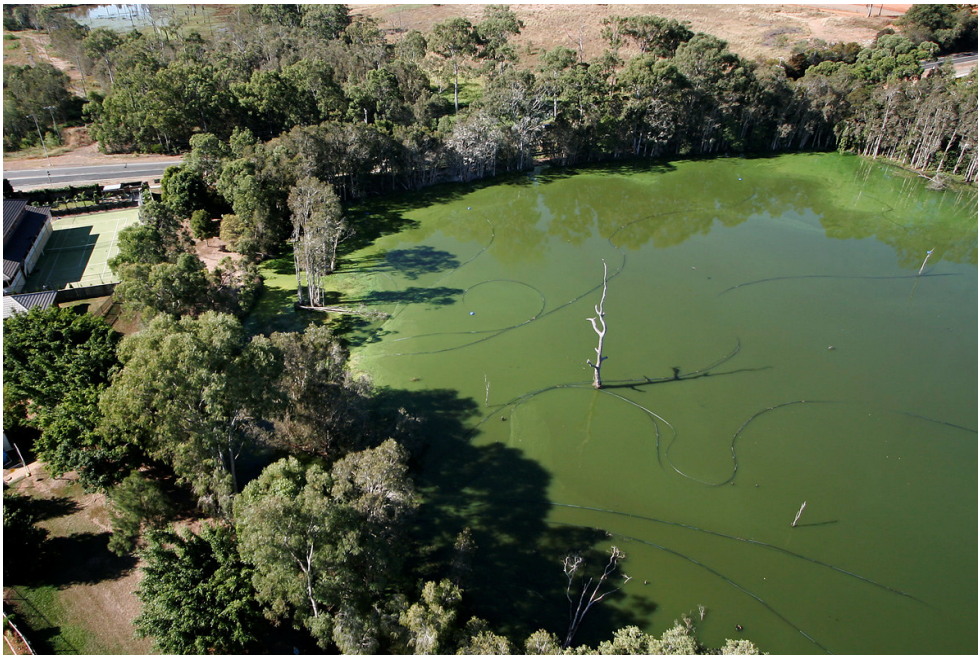
**Figure 2 Algal bloom in an urban waterbody**
